A STAMP ANALYSIS OF THE LEX COMAIR 5191 ACCIDENT

Thesis submitted in partial fulfilment of the requirements
for the MSc in Human Factors and System Safety

Paul S. Nelson

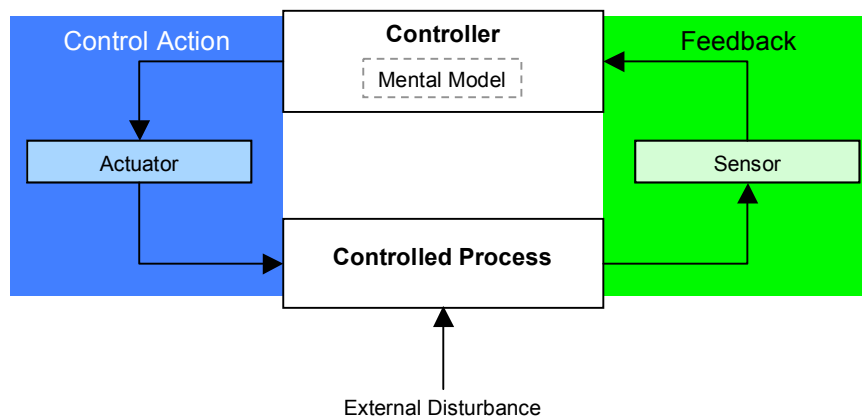
Figure 1 Basic Process Loop

One such model has been developed by Nancy Leveson, Systems—Theoretic Accident Modeling and Processes (STAMP). STAMP is built upon systems theory. At its core are the ideas of emergence and hierarchy, and communication and control. Concentration is on the system as a whole as apposed to separating its parts. Accidents occur because of "inadequate control or enforcement of safety-related constraints" as apposed to simple component failures (Leveson, Daouk, Dulac & Marais, 2003, p. 3). Component interactions which break the system safety constraints generate events which are the result of inadequate control. However, mere identification of the inadequate control is not a stopping point. The systems control structure, itself, "must be examined to determine why the controls for each component at each hierarchical level were inadequate to maintain the constraints on safe behavior and why the events occurred" (Leveson et al., 2003, p. 3). Controllers act in harmony with their mental, or process models of the system¹. These models are updated and kept consistent with information received through feedback in the process loop. Finally, the entire process occurs within a contextual environment.

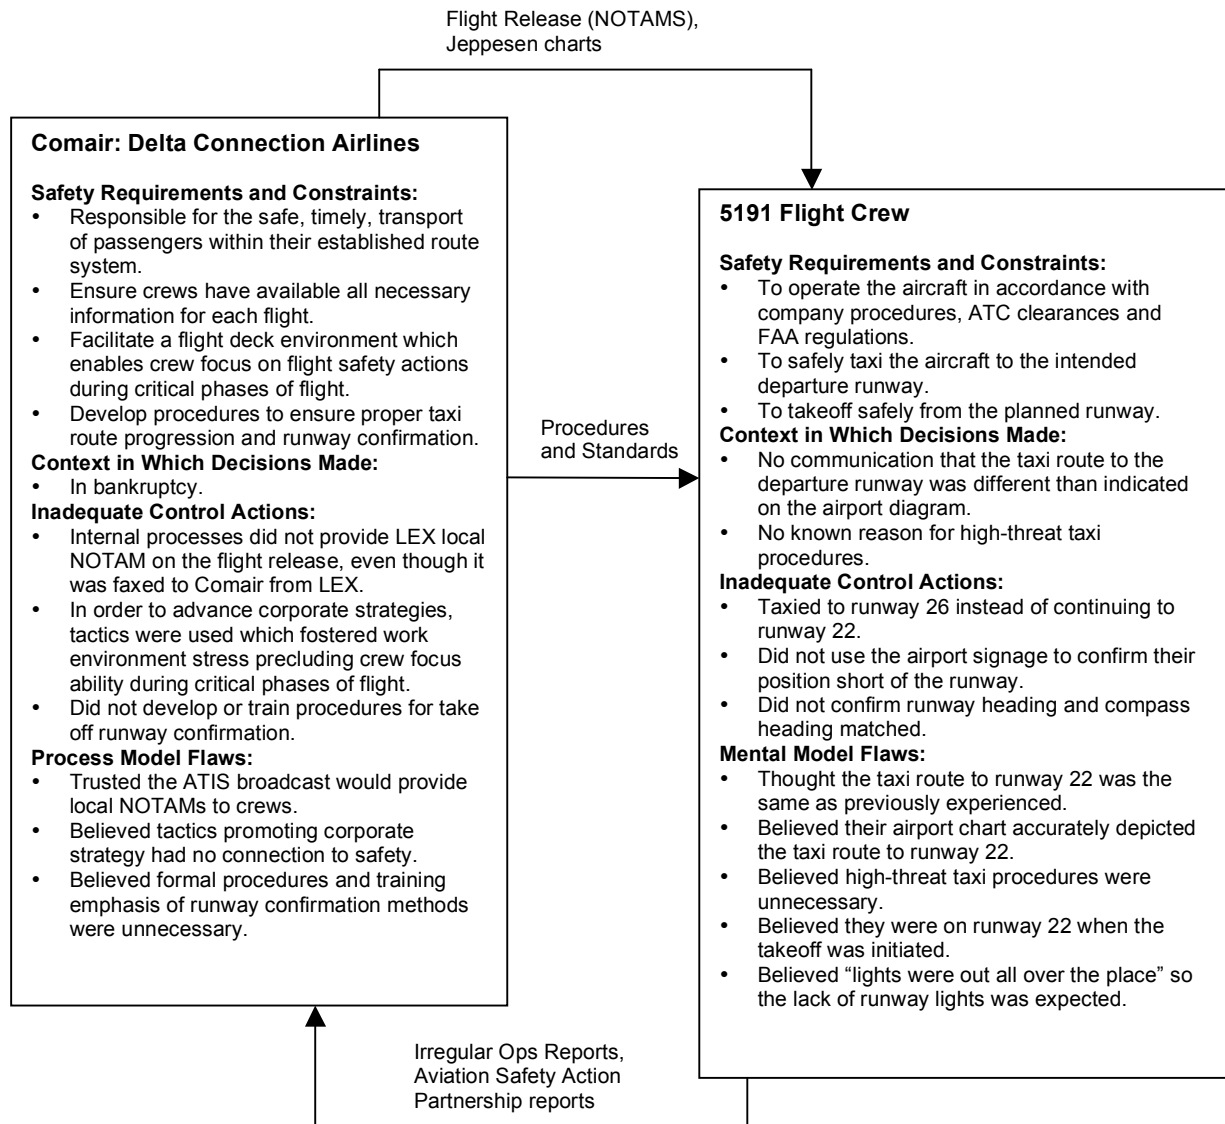
Figure 3 Comair Airlines Control Structure

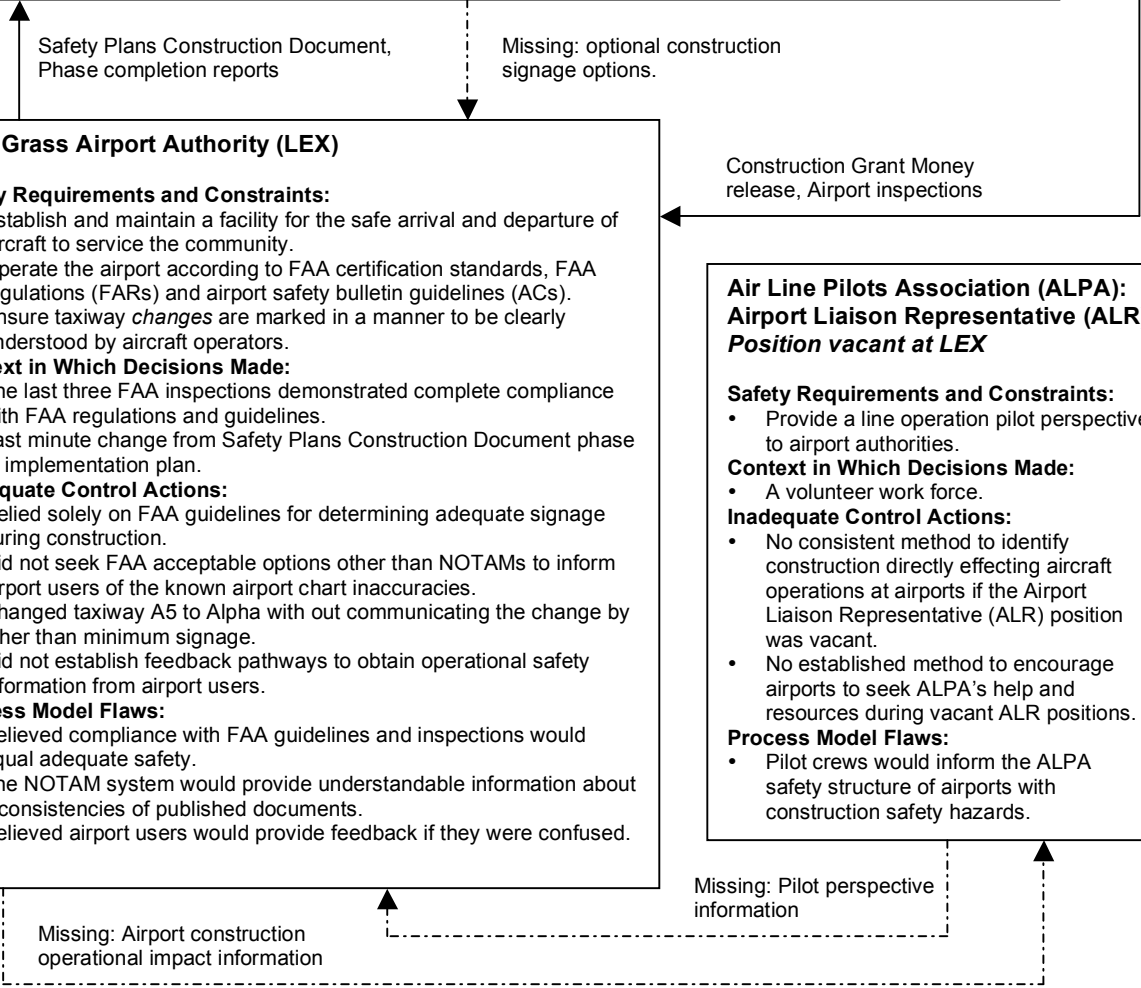
Figure 4 Airport Facilities Control Structure

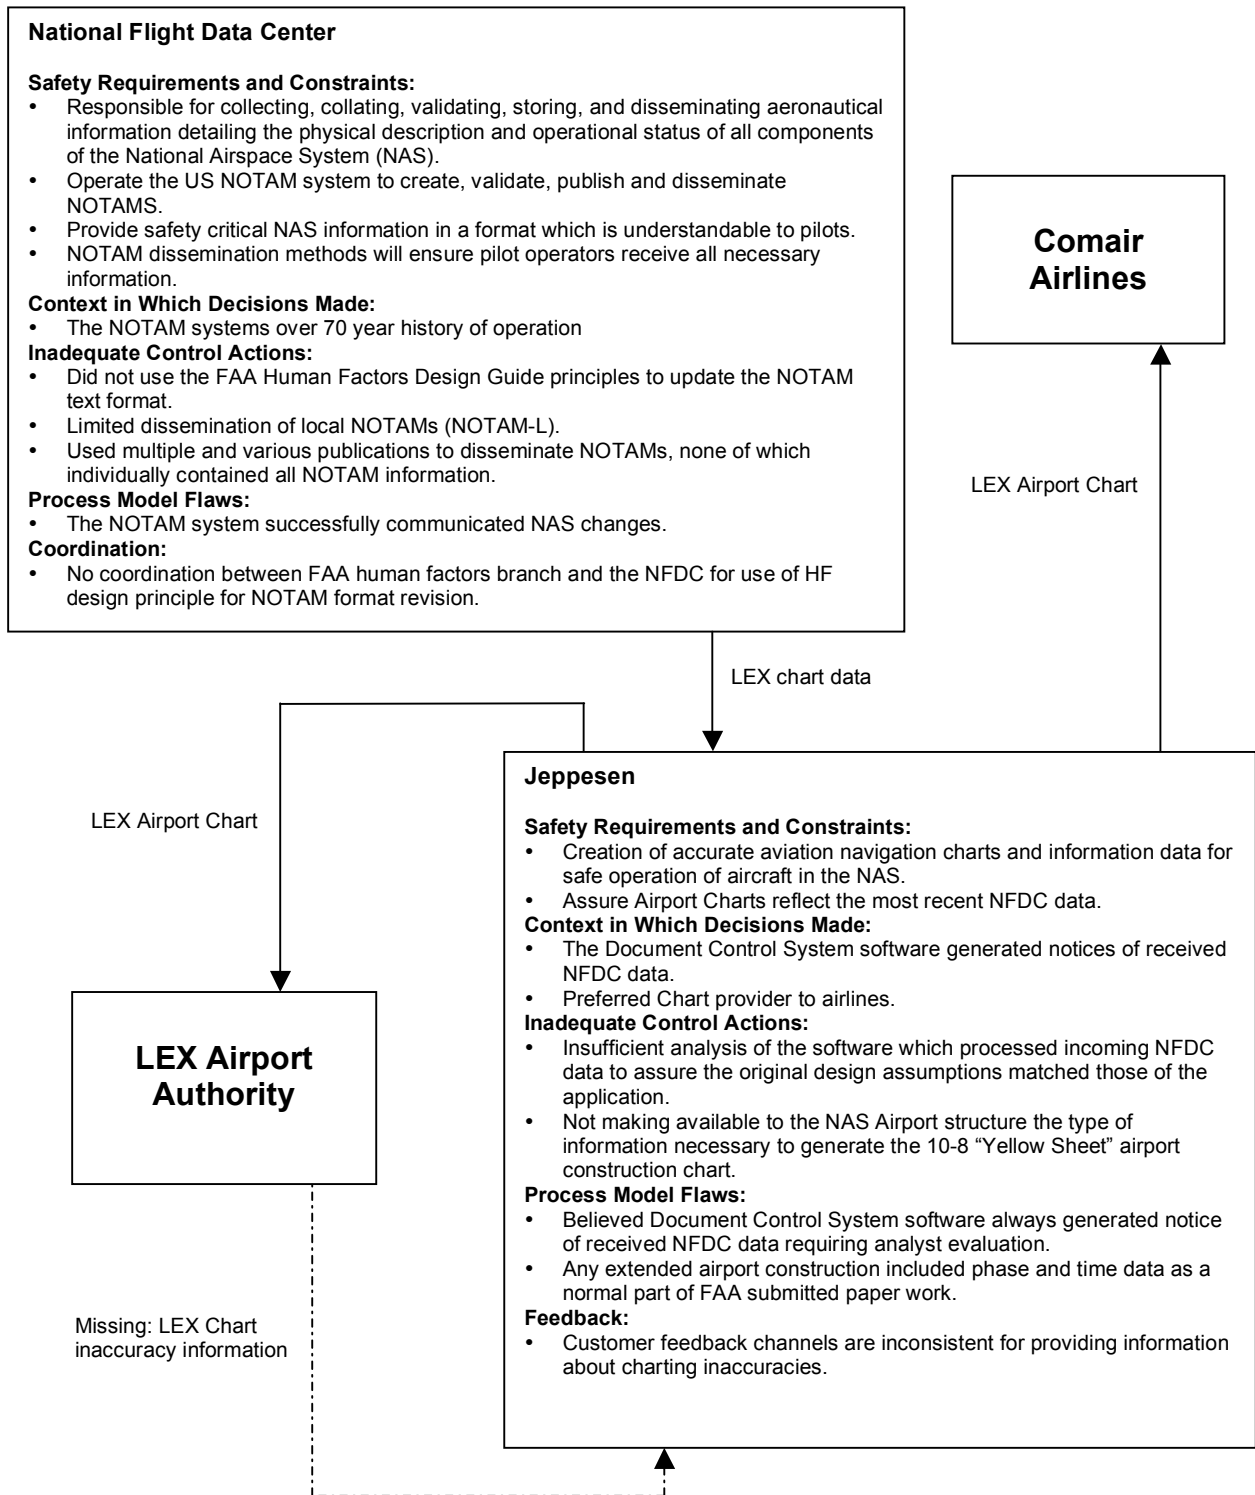
Figure 8 NFDC Charting Data Structure

On the day of the 5191 accident, the Jeppesen airport diagram for LEX did not reflect the most recent National Flight Data Center (NFDC) information. Even though the NFDC information was also inconsistent with the physical layout of North end taxiways, it most closely matched reality (Air Line Pilots Association International, 2007).

Jeppesen used a document control system (DCS) to process National Airspace System (NAS) information received from the National Flight Data Center (NFDC). The DCS software reports received information for an analyst to review and incorporate in the necessary charts. The DCS software was designed to only make reports of information received during business hours Monday through Friday. However, the knowledge of this software design protocol was not discovered until the 5191 accident prompted an internal Jeppesen analysis of the DCS software (Fedok, 2006).

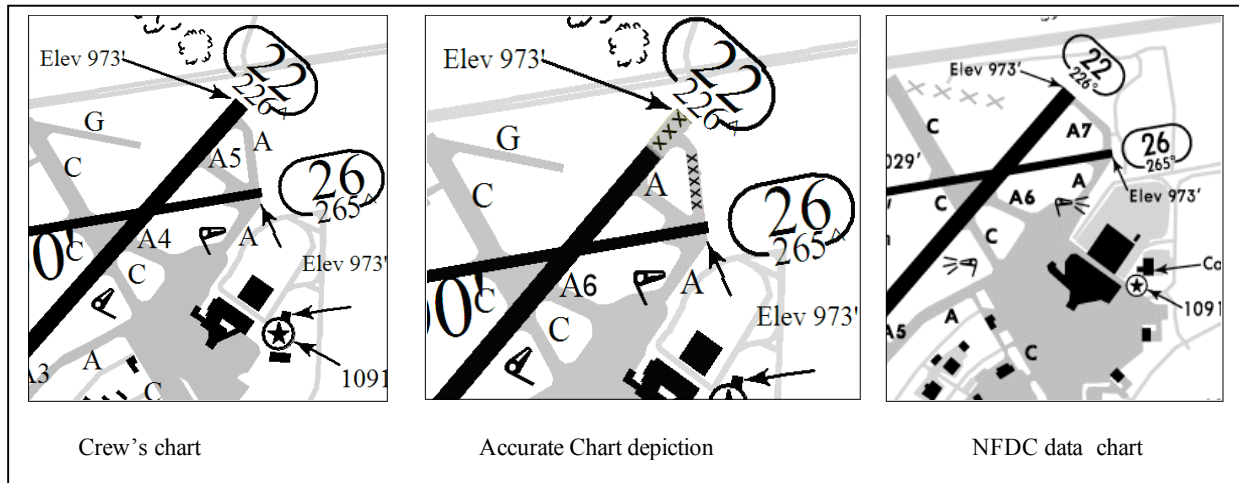
Figure 9 North end of LEX airport
